**National Highway
Traffic Safety
Administration**

Case Vehicle (A): 1999 Pontiac
 Type: Grand Am, 2-door coupe
 Driver: 28-year-old male
 CDC: 12-FREN-5, 12-LDES-2

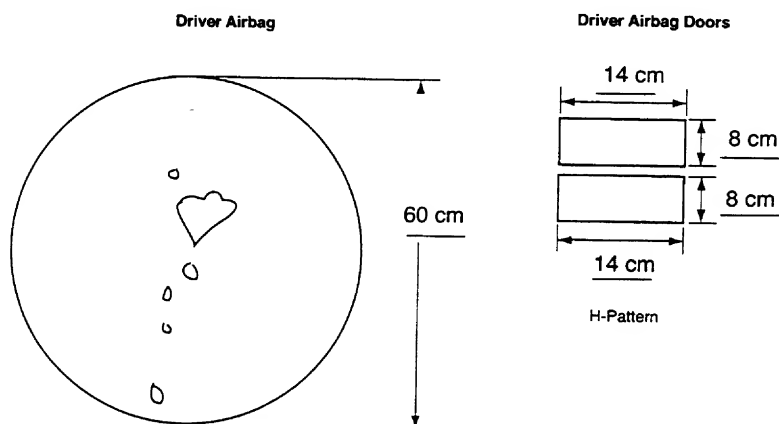
AIRBAG AB-2**AIRBAG NUMBER ON DRIVER SIDE:**NOTE AND DESCRIBE ANY AIRBAG CONTACT OR
DAMAGE ON DIAGRAM BELOW:

Vents: ☒ Y ☐ N
 if yes, how many: 2

Tethers: ☒ Y ☐ N
 if yes, how many: 2
AIRBAG NUMBER ON PASSENGER SIDE:NOTE AND DESCRIBE ANY AIRBAG CONTACT OR
DAMAGE ON DIAGRAM BELOW:

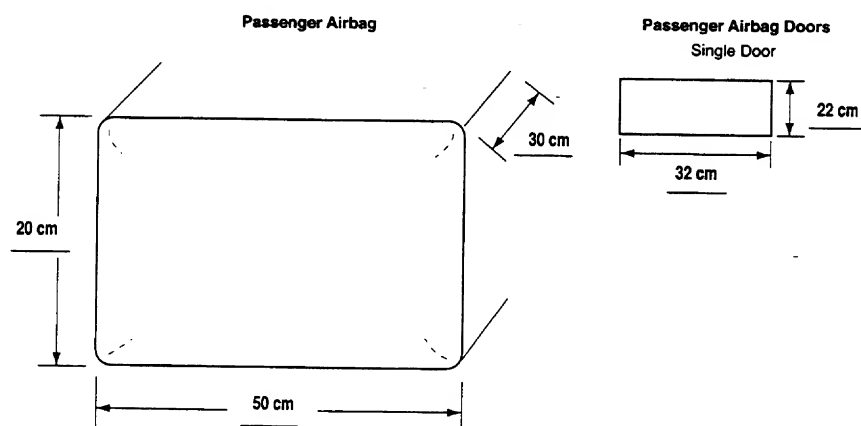
Vents: Y ☒ N
 if yes, how many: _____

Tethers: Y ☒ N
 if yes, how many: _____
